Coating Performance in Duluth Superior Harbor—Part 2

RICHARD I. RAY AND BRENDA J. LITTLE, FNACE,
Naval Research Laboratory, Stennis Space Center, Mississippi

Nine coatings were evaluated for corrosion protection of carbon steel coupons and I-beams around Duluth Superior Harbor after 46 and 35 months, respectively. Coupons were intentionally scribed to metal before exposure. Part 1 (September 2012 MP) described the coatings used and the locations of coupons and I-beams. Part 2 discusses the results of the evaluation.

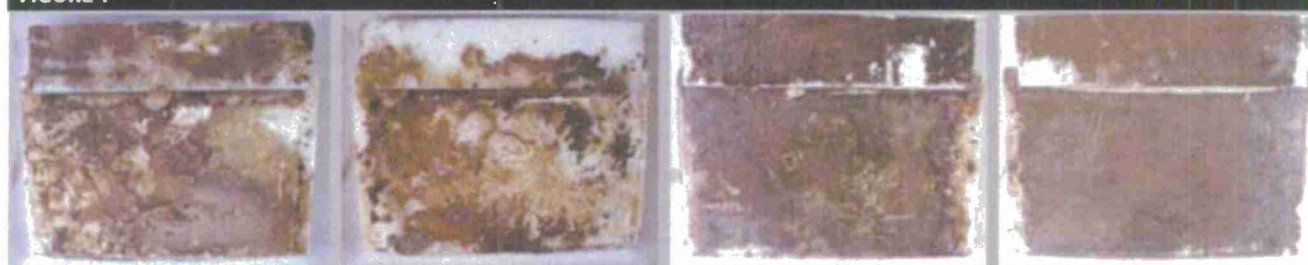
FIGURE 1

(Side A) Coating 1 (Side B)
U.S. Coast Guard Cell B
 White two-part solvent-free polyamine epoxy
 Total exposure time 46 months

Observations
 Few byssal threads still attached
 Both sides covered in sponge material
 Top layer of coating peeling in places
 Corrosion evident in scribe (artificial defect)
 Muddy coating on surface

(Side A) Coating 1 (Side B)
U.S. Coast Guard Cell C
 White two-part solvent-free polyamine epoxy
 Total exposure time 46 months

Observations
 Few byssal threads still attached
 Algae growing on one side of coupon
 Top layer of coating peeling from scribe
 Corrosion evident in scribe (artificial defect)
 Muddy coating on surface

Coating 1 coupons.

to the intentional scribe area. The topcoat of Coating 1 was peeling from the scribe. Coatings 4, 5, 6, 7, and 9 remained intact and there were no indications of delamination even in the scribe area. Figures 1 through 4 present descriptions and observations.

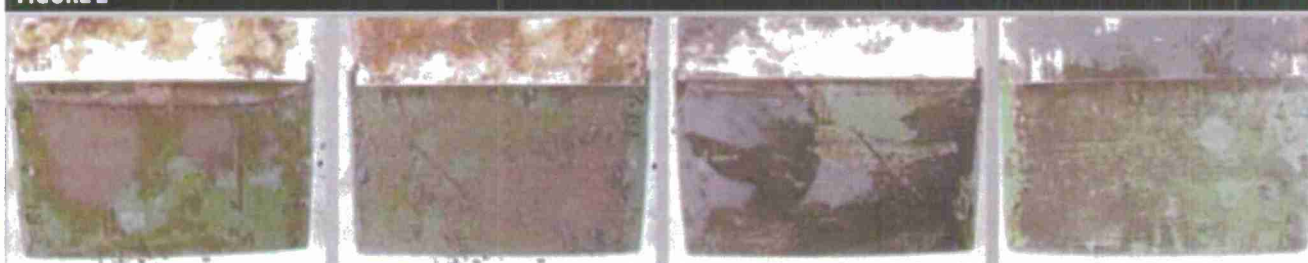
FIGURE 2

(Side A) Coating 4 (Side B)
U.S. Coast Guard Cell B
 Green two-part solvent-free polyamine epoxy
 Total exposure time 46 months

Observations
 Few byssal threads still attached
 Coating appears intact even in scribe area
 Corrosion evident in scribe
 Muddy coating on surface

(Side A) Coating 4 (Side B)
U.S. Coast Guard Cell C
 Green two-part solvent-free polyamine epoxy
 Total exposure time 46 months

Observations
 Few byssal threads still attached
 Coating appears intact even in scribe area
 Corrosion evident in scribe
 Muddy coating on surface except where
 silicone caulk used to attach Teflon holder

Coating 4 coupons.

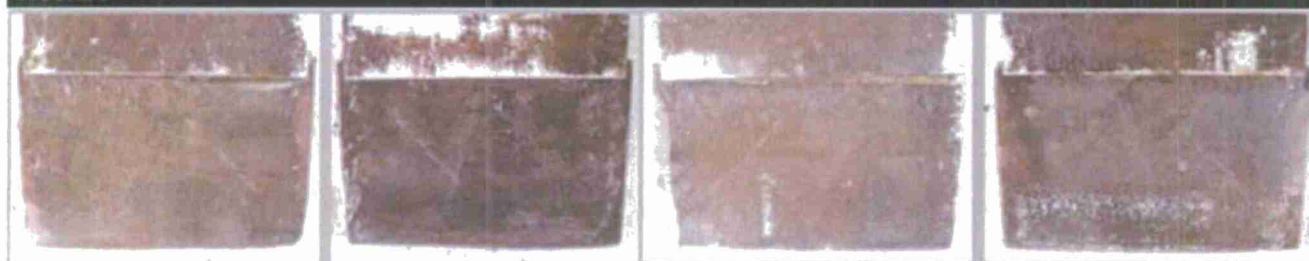
FIGURE 3

Coating 5
(Side A) (Side B)
U.S. Coast Guard Cell C
Red urethane micaceous iron oxides
and refined coal tar
Total exposure time 46 months

Observations
Few byssal threads still attached
Some algae on coating surface
Coating appears intact even in scribe area
Corrosion evident in scribe
Muddy coating on surface

Coating 9
(Side A) (Side B)
U.S. Coast Guard Cell C
Blue/grey zinc primer/vinyl copolymers
Total exposure time 46 months

Coatings 5 and 9 coupons.

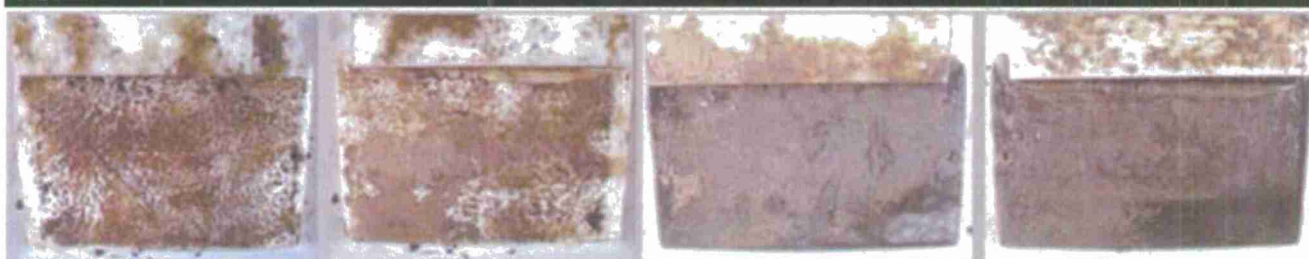
FIGURE 4

Coating 6
(Side A) (Side B)
U.S. Coast Guard Cell B
White amine epoxy (one coat)
Total exposure time 46 months

Observations
Few byssal threads still attached
Coating appears intact even in scribe area
Coating lumpy and thick
Corrosion evident in scribe
Muddy coating on surface

Coating 7
(Side A) (Side B)
U.S. Coast Guard Cell C
Black polysulfide modified epoxy novolac
Total exposure time 46 months

Observations
Few byssal threads still attached
Some algae on coating surface
Coating appears intact even in scribe area
Corrosion evident in scribe
Muddy coating on surface

Coatings 6 and 7 coupons.

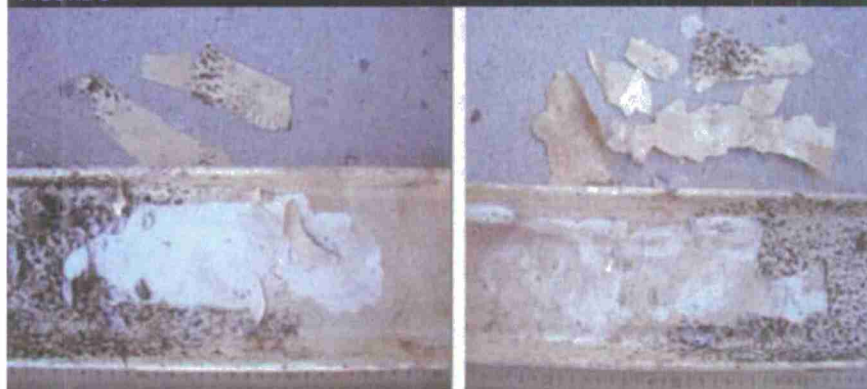
FIGURE 5

The topcoat of Coating 1 delaminated and peeled from the surface of the I-beam (Figure 5).

The I beams were not scribed so the intentional defect was not necessary to initiate the delamination. The base coat remained intact and no localized corrosion was obvious. Coating 7 peeled from the surface in large sections, exposing uncoated steel with corrosion and tubercles (Figure 6).

Coating 1 shown on the I-beams.

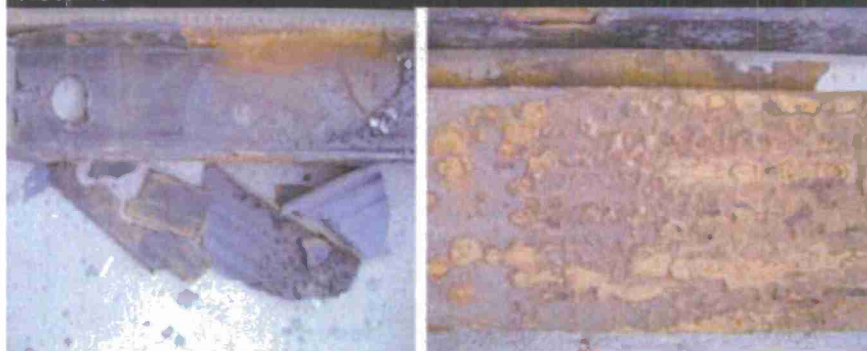
FIGURE 6

Coating 7 shown on the I-beams.
